## Overheating of AISI4140

Report Written by M. Williamson BEng

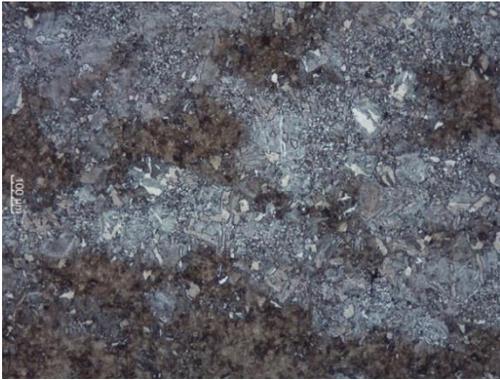
Photo A

As the structure is not homogeneous it is evident that there are areas of coarse and areas of fine grains. This is what is known as “badly heat treated steel”. This material was overheated during the hot working operation and then the components were placed in stillage’s and left to cool. The problem of stacked and therefore crowded components in the stillage, leads to various uneven cooling rates around the component, therefore depending on the components position within the stillage depended on what cooling it received. These components weighed 26Kg so the microstructure did vary at different positions (see photos below).

Photo A, B, C – Martensite (dark), ferrite/pearlite aggregate (light), bainite (large grains) x100

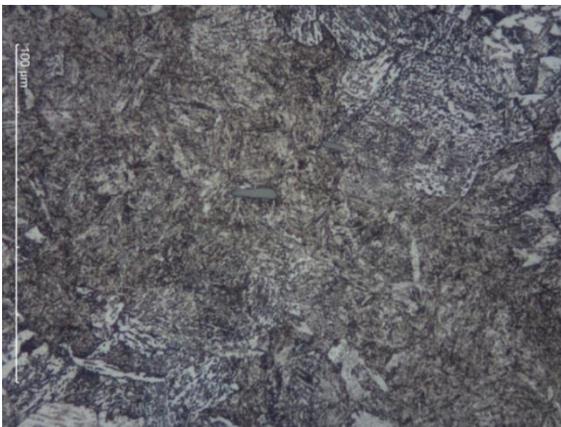
Photo D – Martensite with MnS inclusion x400

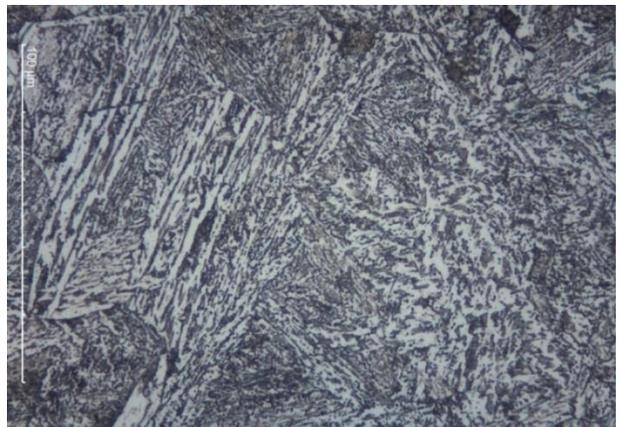
Photo E – Ferrite/pearlite aggregate x400: pearlite is normally formed on delayed cooling from austenite

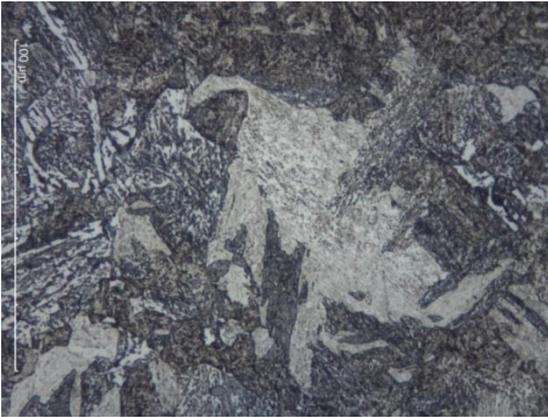
Photo F – Martensite (dark), ferrite/pearlite aggregate (light), bainite (large grain) x400

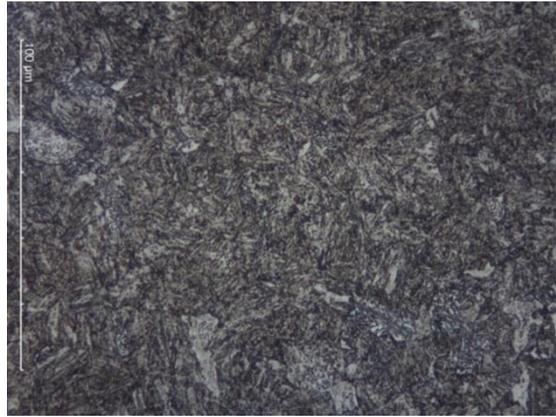
Photo G - martensite x400
